**VENEZUELA COMMUNITY WASTEWATER AND STORMWATER
COLLECTION SYSTEMS**

Reconnaissance Inspection: Puerto Rico Aqueduct and Sewer Authority (PRASA) Puerto
Nuevo Regional Wastewater Treatment Plant (RWWTP) NPDES
Permit (PR0021555)

Autonomous Municipality of San Juan (MSJ) Municipal Separate
Storm Sewer System (MS4)
National Pollutant Discharge Elimination System (NPDES) Permit
(PRR040036)

Inspection Date: May 26, 2015

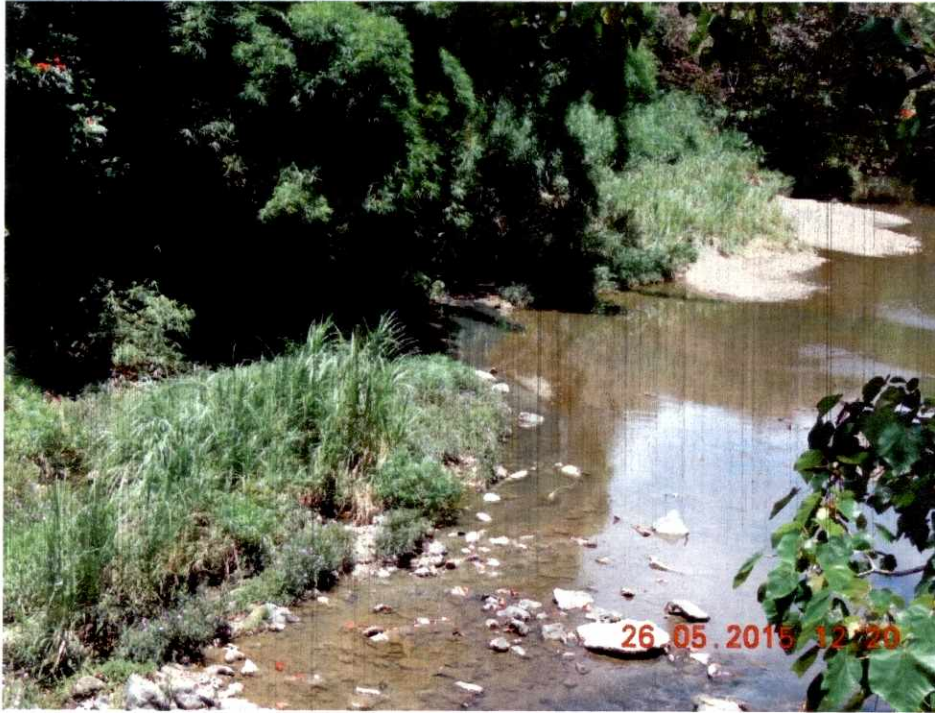
1. A discharge with wastewater characteristics (e.g. color and algae formation) was observed from the PR-1 Bridge adjacent (west) to the University of Puerto Rico Botanical Garden South Entrance and reaching the Río Piedras River. See photos DSCN2127 thru DSCN2129 located in **Attachment I** for more details.

DSCN2127 – View of a discharge with wastewater characteristics (e.g. color and algae formation) that was observed from the PR-1 Bridge adjacent (west) to the University of Puerto Rico Botanical Garden South Entrance and reaching the Río Piedras River.

MSJ and PRASA shall take the necessary actions to cease discharging wastewaters into Waters of the United States. The response to this report shall include all the details, evidence, and results of such actions.

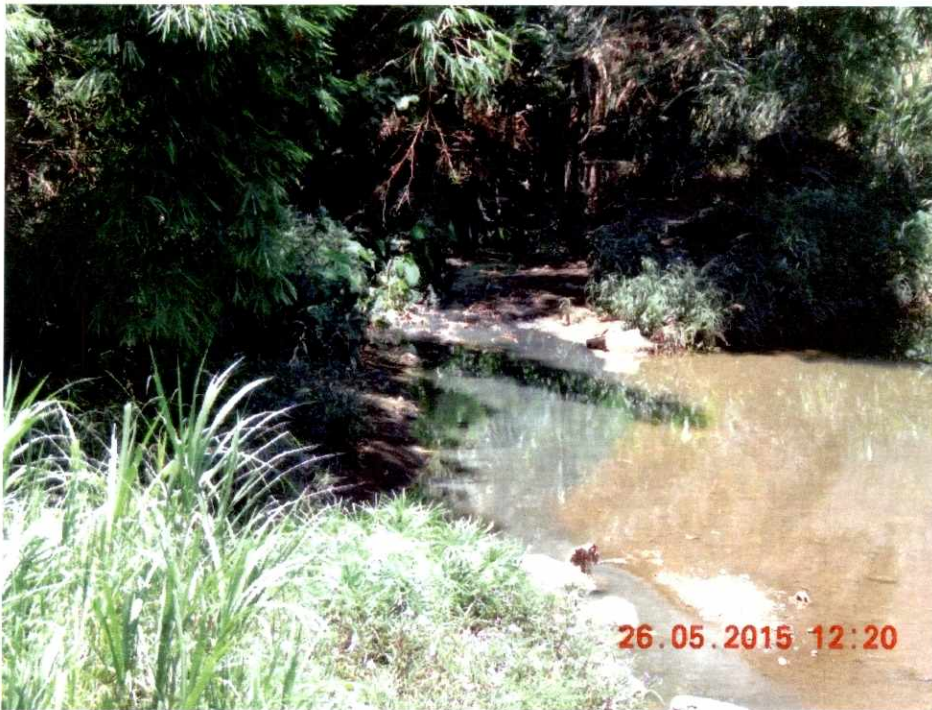
DSCN2128 – Additional view of a discharge with wastewater characteristics (e.g. color and algae formation) that was observed from the PR-1 Bridge adjacent (west) to the University of Puerto Rico Botanical Garden South Entrance and reaching the Río Piedras River.

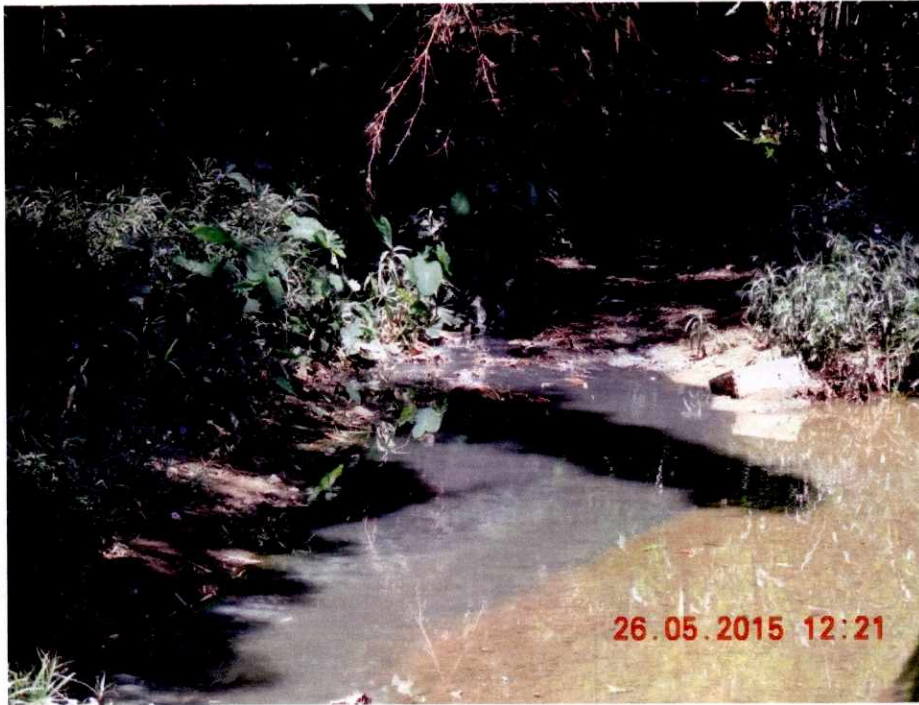
DSCN2129 – Additional view of a discharge with wastewater characteristics (e.g. color and algae formation) that was observed from the PR-1 Bridge adjacent (west) to the University of Puerto Rico Botanical Garden South Entrance and reaching the Río Piedras River.

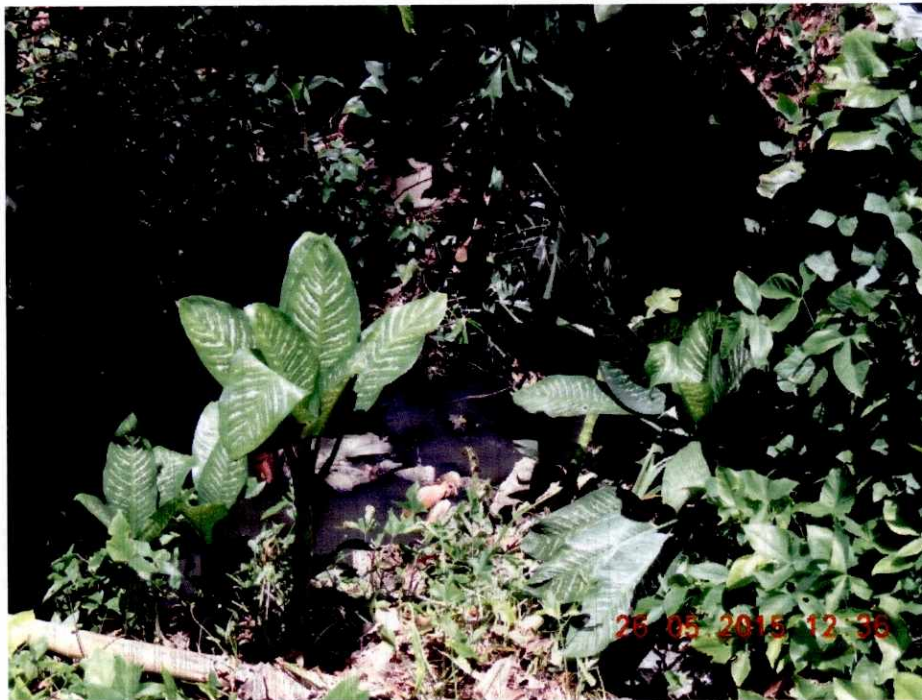
2. Large amounts of wastewater was found reaching the Río Piedras River through an approximately 48 inches circular pipe. Coordinates: Lat. 18° 23' 37.79" N – Long. 66° 3' 19.59" W. See photos DSCN2130 thru DSCN2135 located in **Attachment I** for more details (video DSCN 2136 and DSCN2137 were also taken).

DSCN2130 – Large amounts of wastewater was found reaching the Río Piedras River through an approximately 48 inches circular pipe.

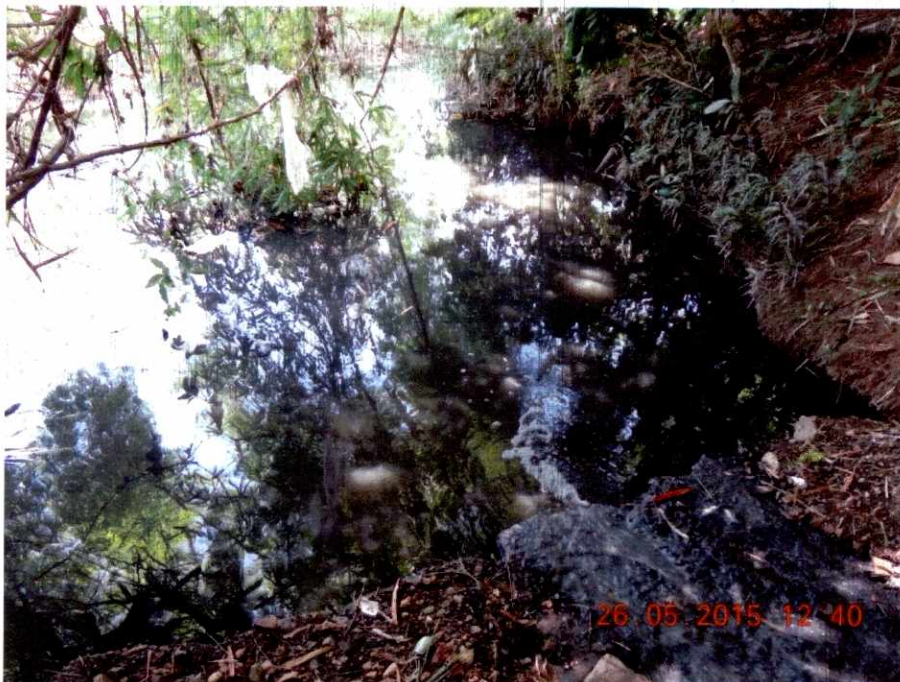
DSCN2131 – View of the discharge point at the Rio Piedras River.

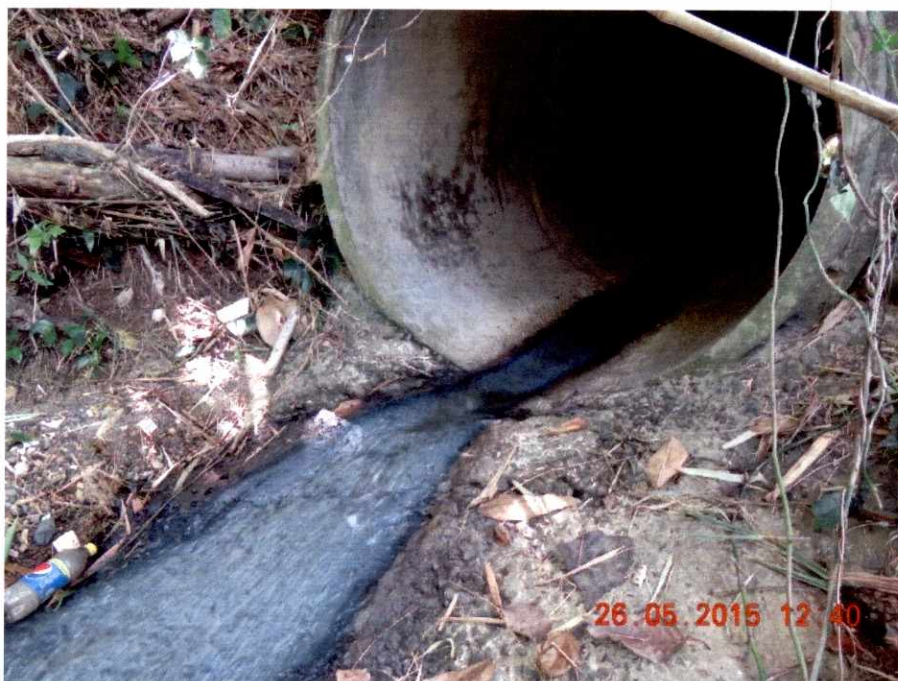
DSCN2132 –View of the approximately 48 inches circular pipe that was found discharging wastewater into the Río Piedras River.

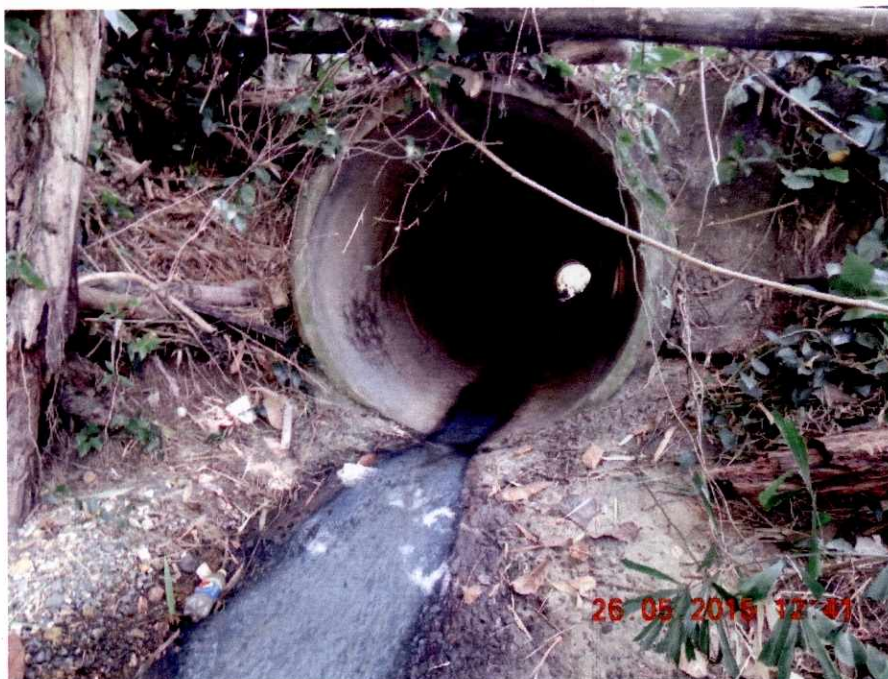
DSCN2133 – Additional view of the approximately 48 inches circular pipe that was found discharging wastewater into the Río Piedras River.

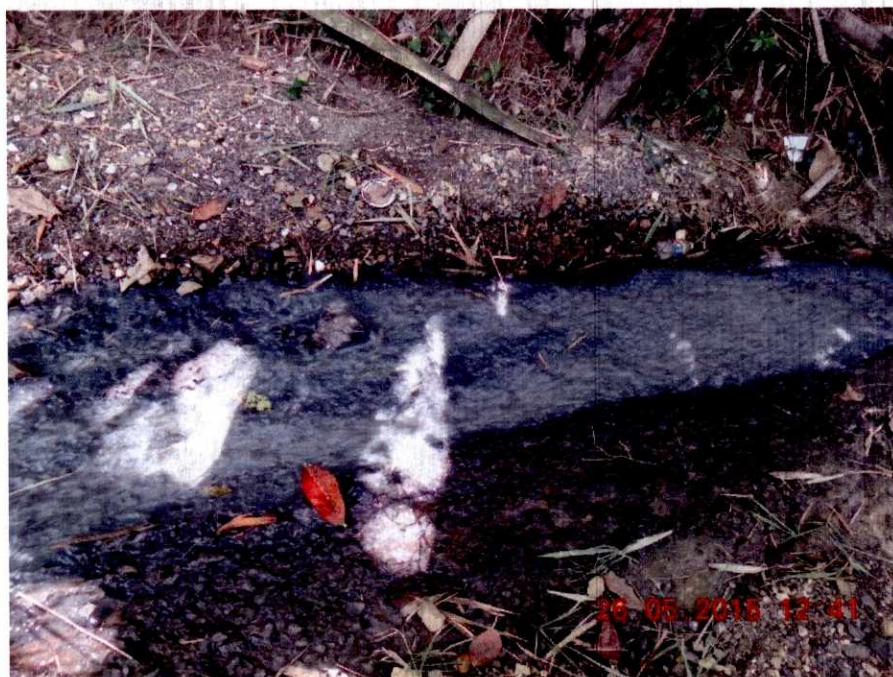
DSCN2134 – Partial view of the discharge of the wastewater reaching the Río Piedras River.

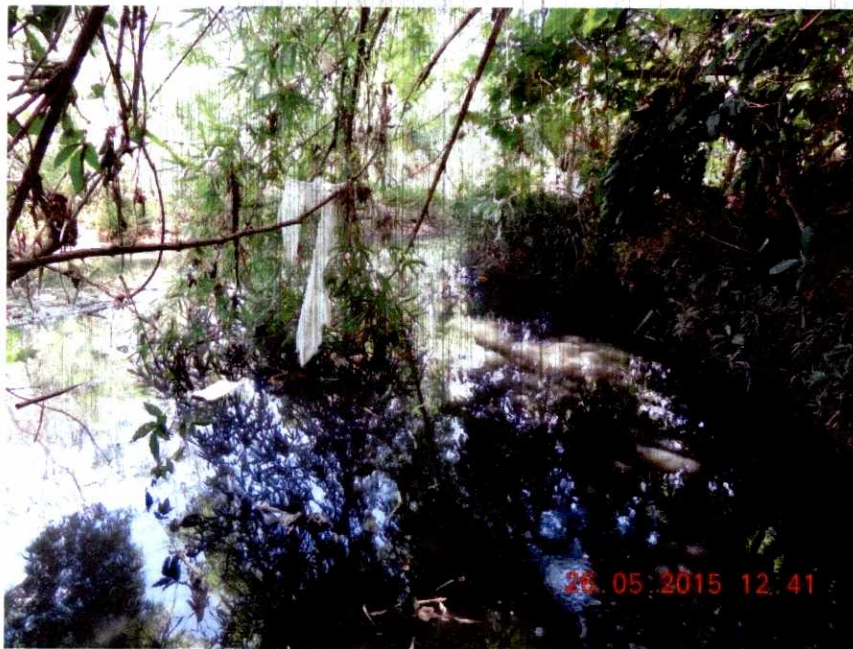
DSCN2135 – Additional view of the discharge point at the Río Piedras River.

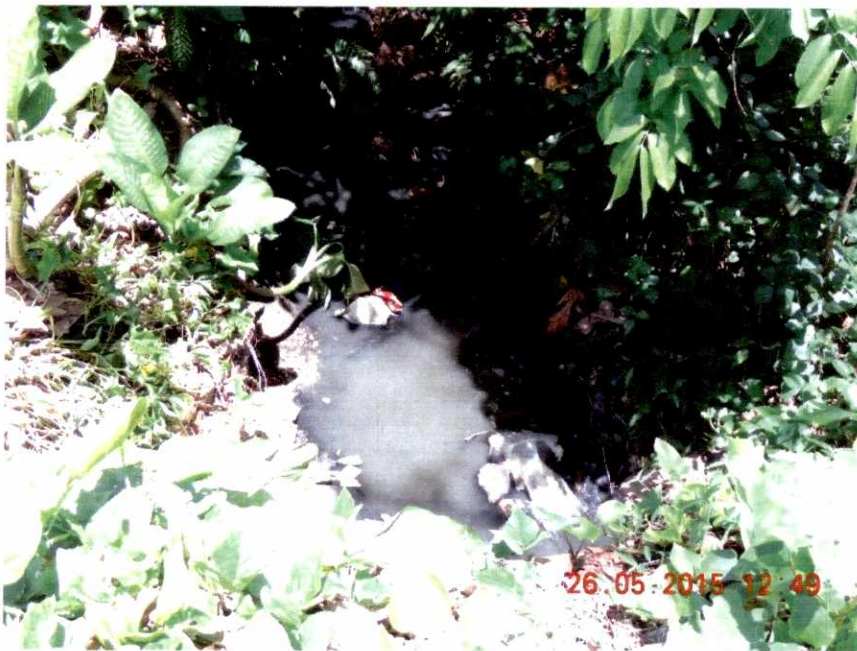
3. The 48 inches circular pipe is conveying an unnamed creek that flows south of the Botanical Garden Security and Vigilance Office. The unnamed creek was found heavily impacted with the presence of wastewater in the area adjacent to the Botanical Garden Security and Vigilance Office. Coordinates: Lat. 18° 23' 37.91" N – Long. 66° 3' 21.20" W. See photo DSCN2138 located in **Attachment I** for more details.

DSCN2138 – View of the unnamed creek from the Botanical Garden Access Road near its Security and Vigilance Office.

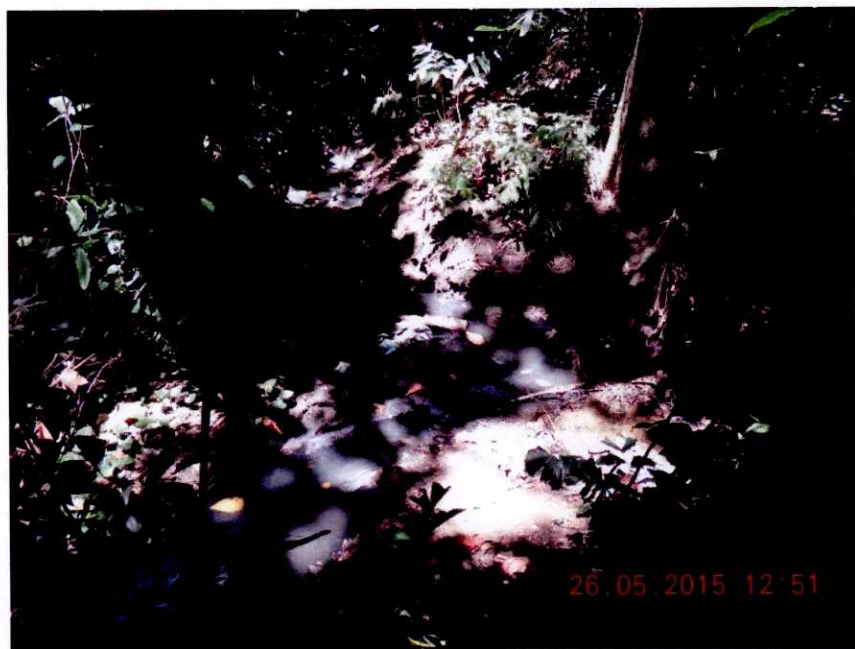
4. The wastewater was observed flowing from the Venezuela Community from an unnamed creek located in between the back of the residences at Venezuela's Guaracanal Street and a public school. Coordinates: Lat. 18° 23' 36.61" N – Long. 66° 3' 15.79" W. See photos DSCN2139 thru DSCN2144 located in **Attachment I** for more details.

DSCN2139 – Partial view of the unnamed creek behind Venezuela's Guaracanal Street Residences.

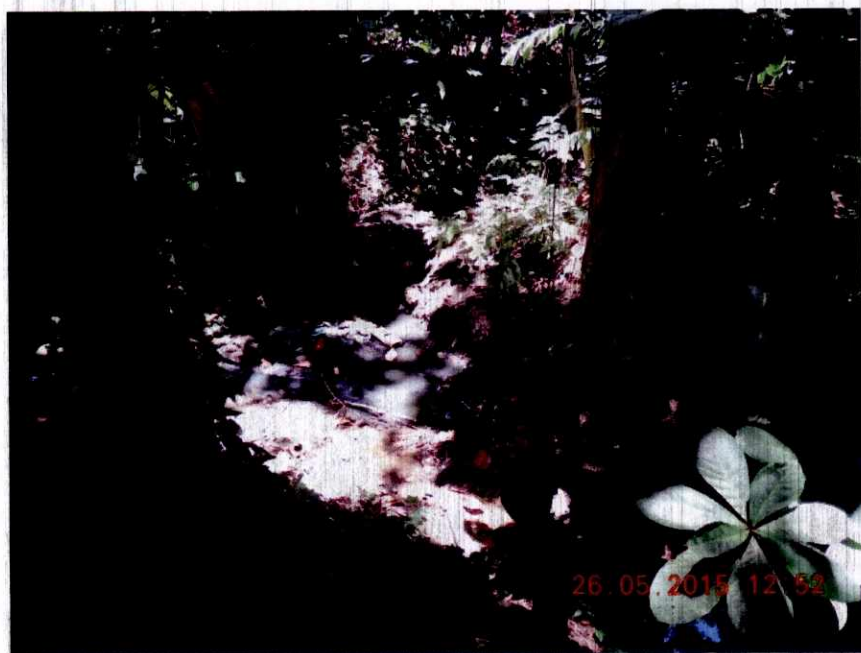
DSCN2140 – Additional view of the unnamed creek behind Venezuela's Guaracanal Street Residences.

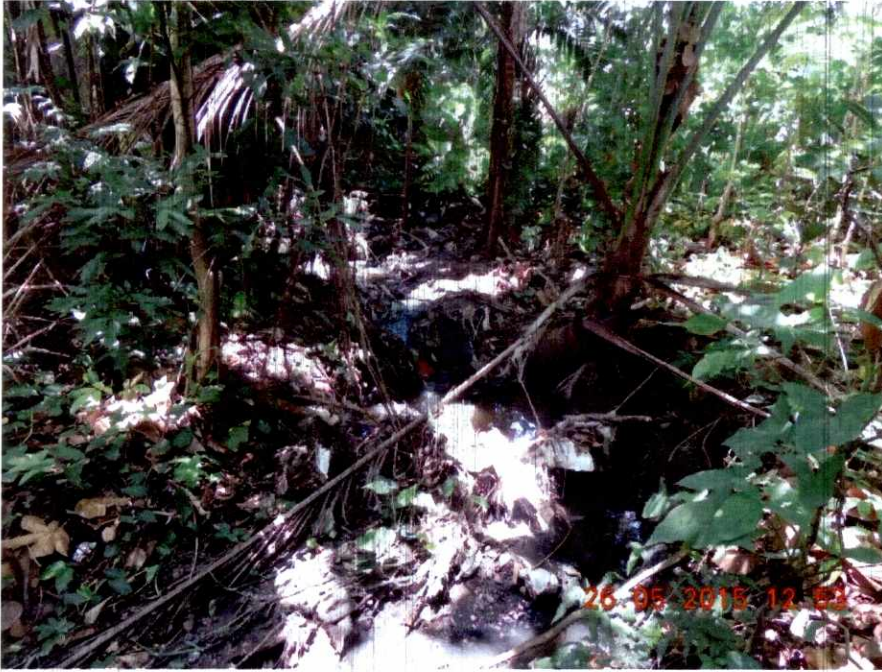
DSCN2141 – Additional view of the unnamed creek behind Venezuela's Guaracanal Street Residences.

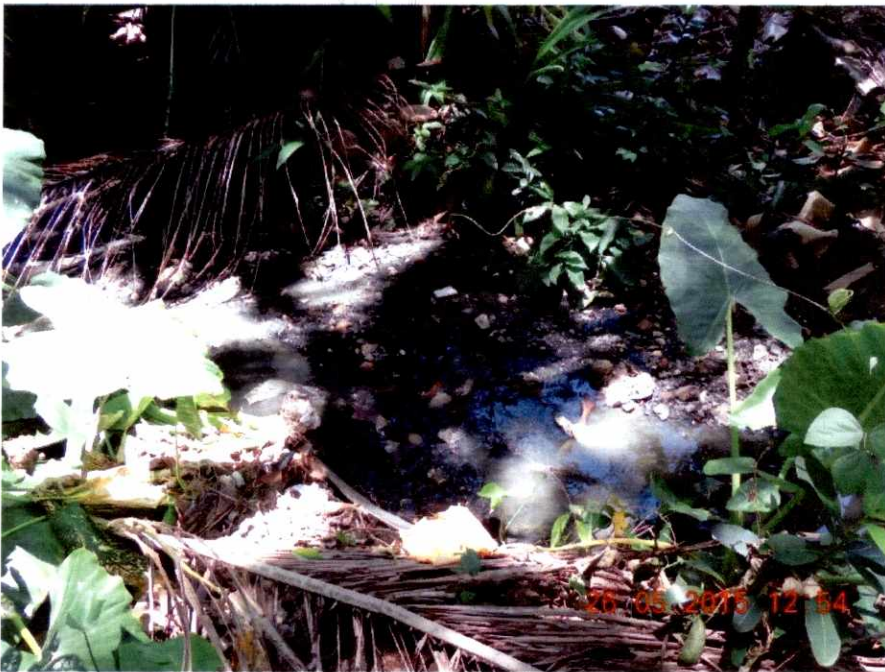
DSCN2142 – Additional view of the unnamed creek behind Venezuela's Guaracanal Street Residences.

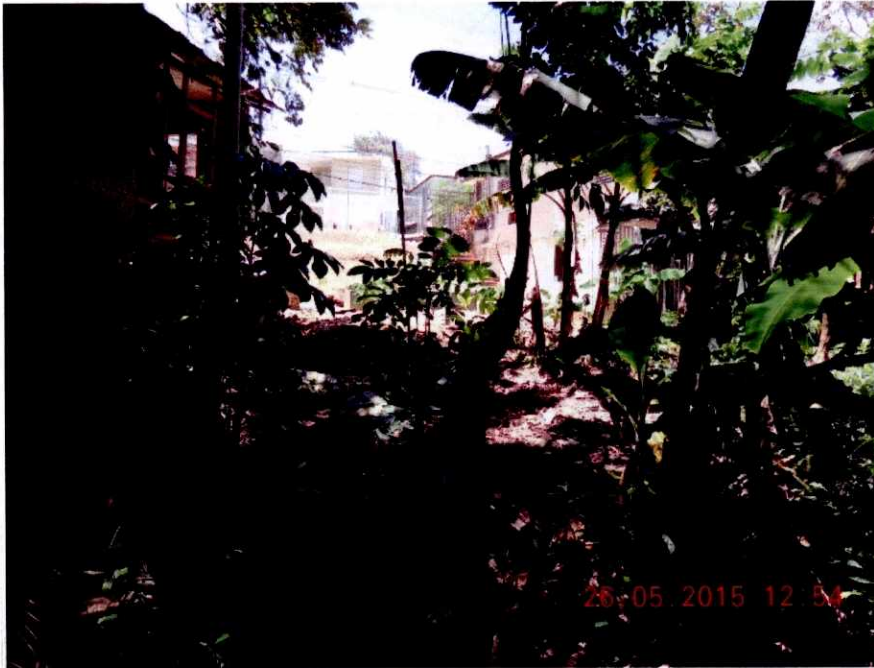
DSCN2143 – View from the unnamed creek in direction to Venezuela Community Guaracanal Street.

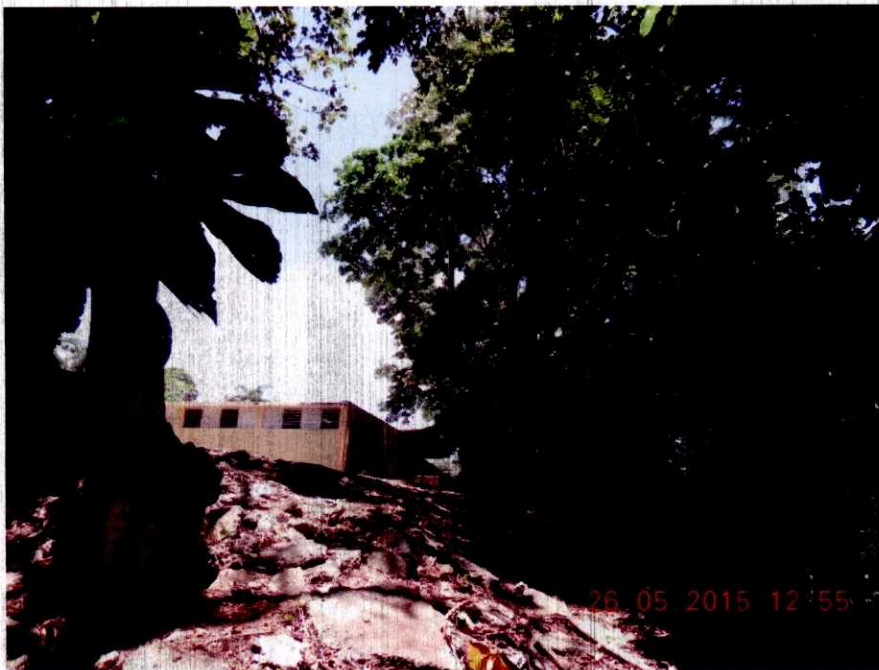
DSCN2144 – View from the unnamed creek in direction to the Venezuela Community Public School.
